Griffith Main Drain J and Mirrool Creek Flood Study

Reference: R.N20024.001.05.docx
Date: February 2015
Final Report

Prepared for: Griffith City Council

Prepared by: BMT WBM Pty Ltd (Member of the BMT group of companies)

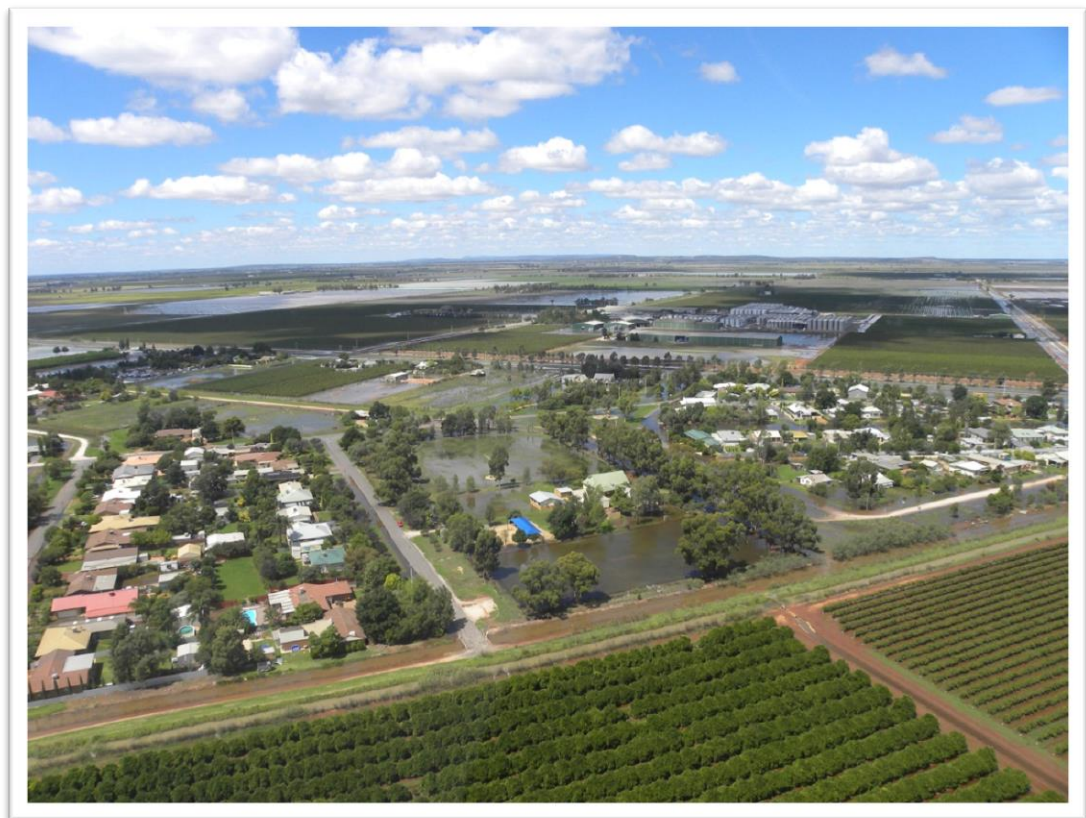
Figure 6-37 Flooding at Bilbul on 5th March 2012 13:04 (Photo G)
